SMOKE TESTING REPORT

Submitted to:
Green Charter
Township

July 2019
839870

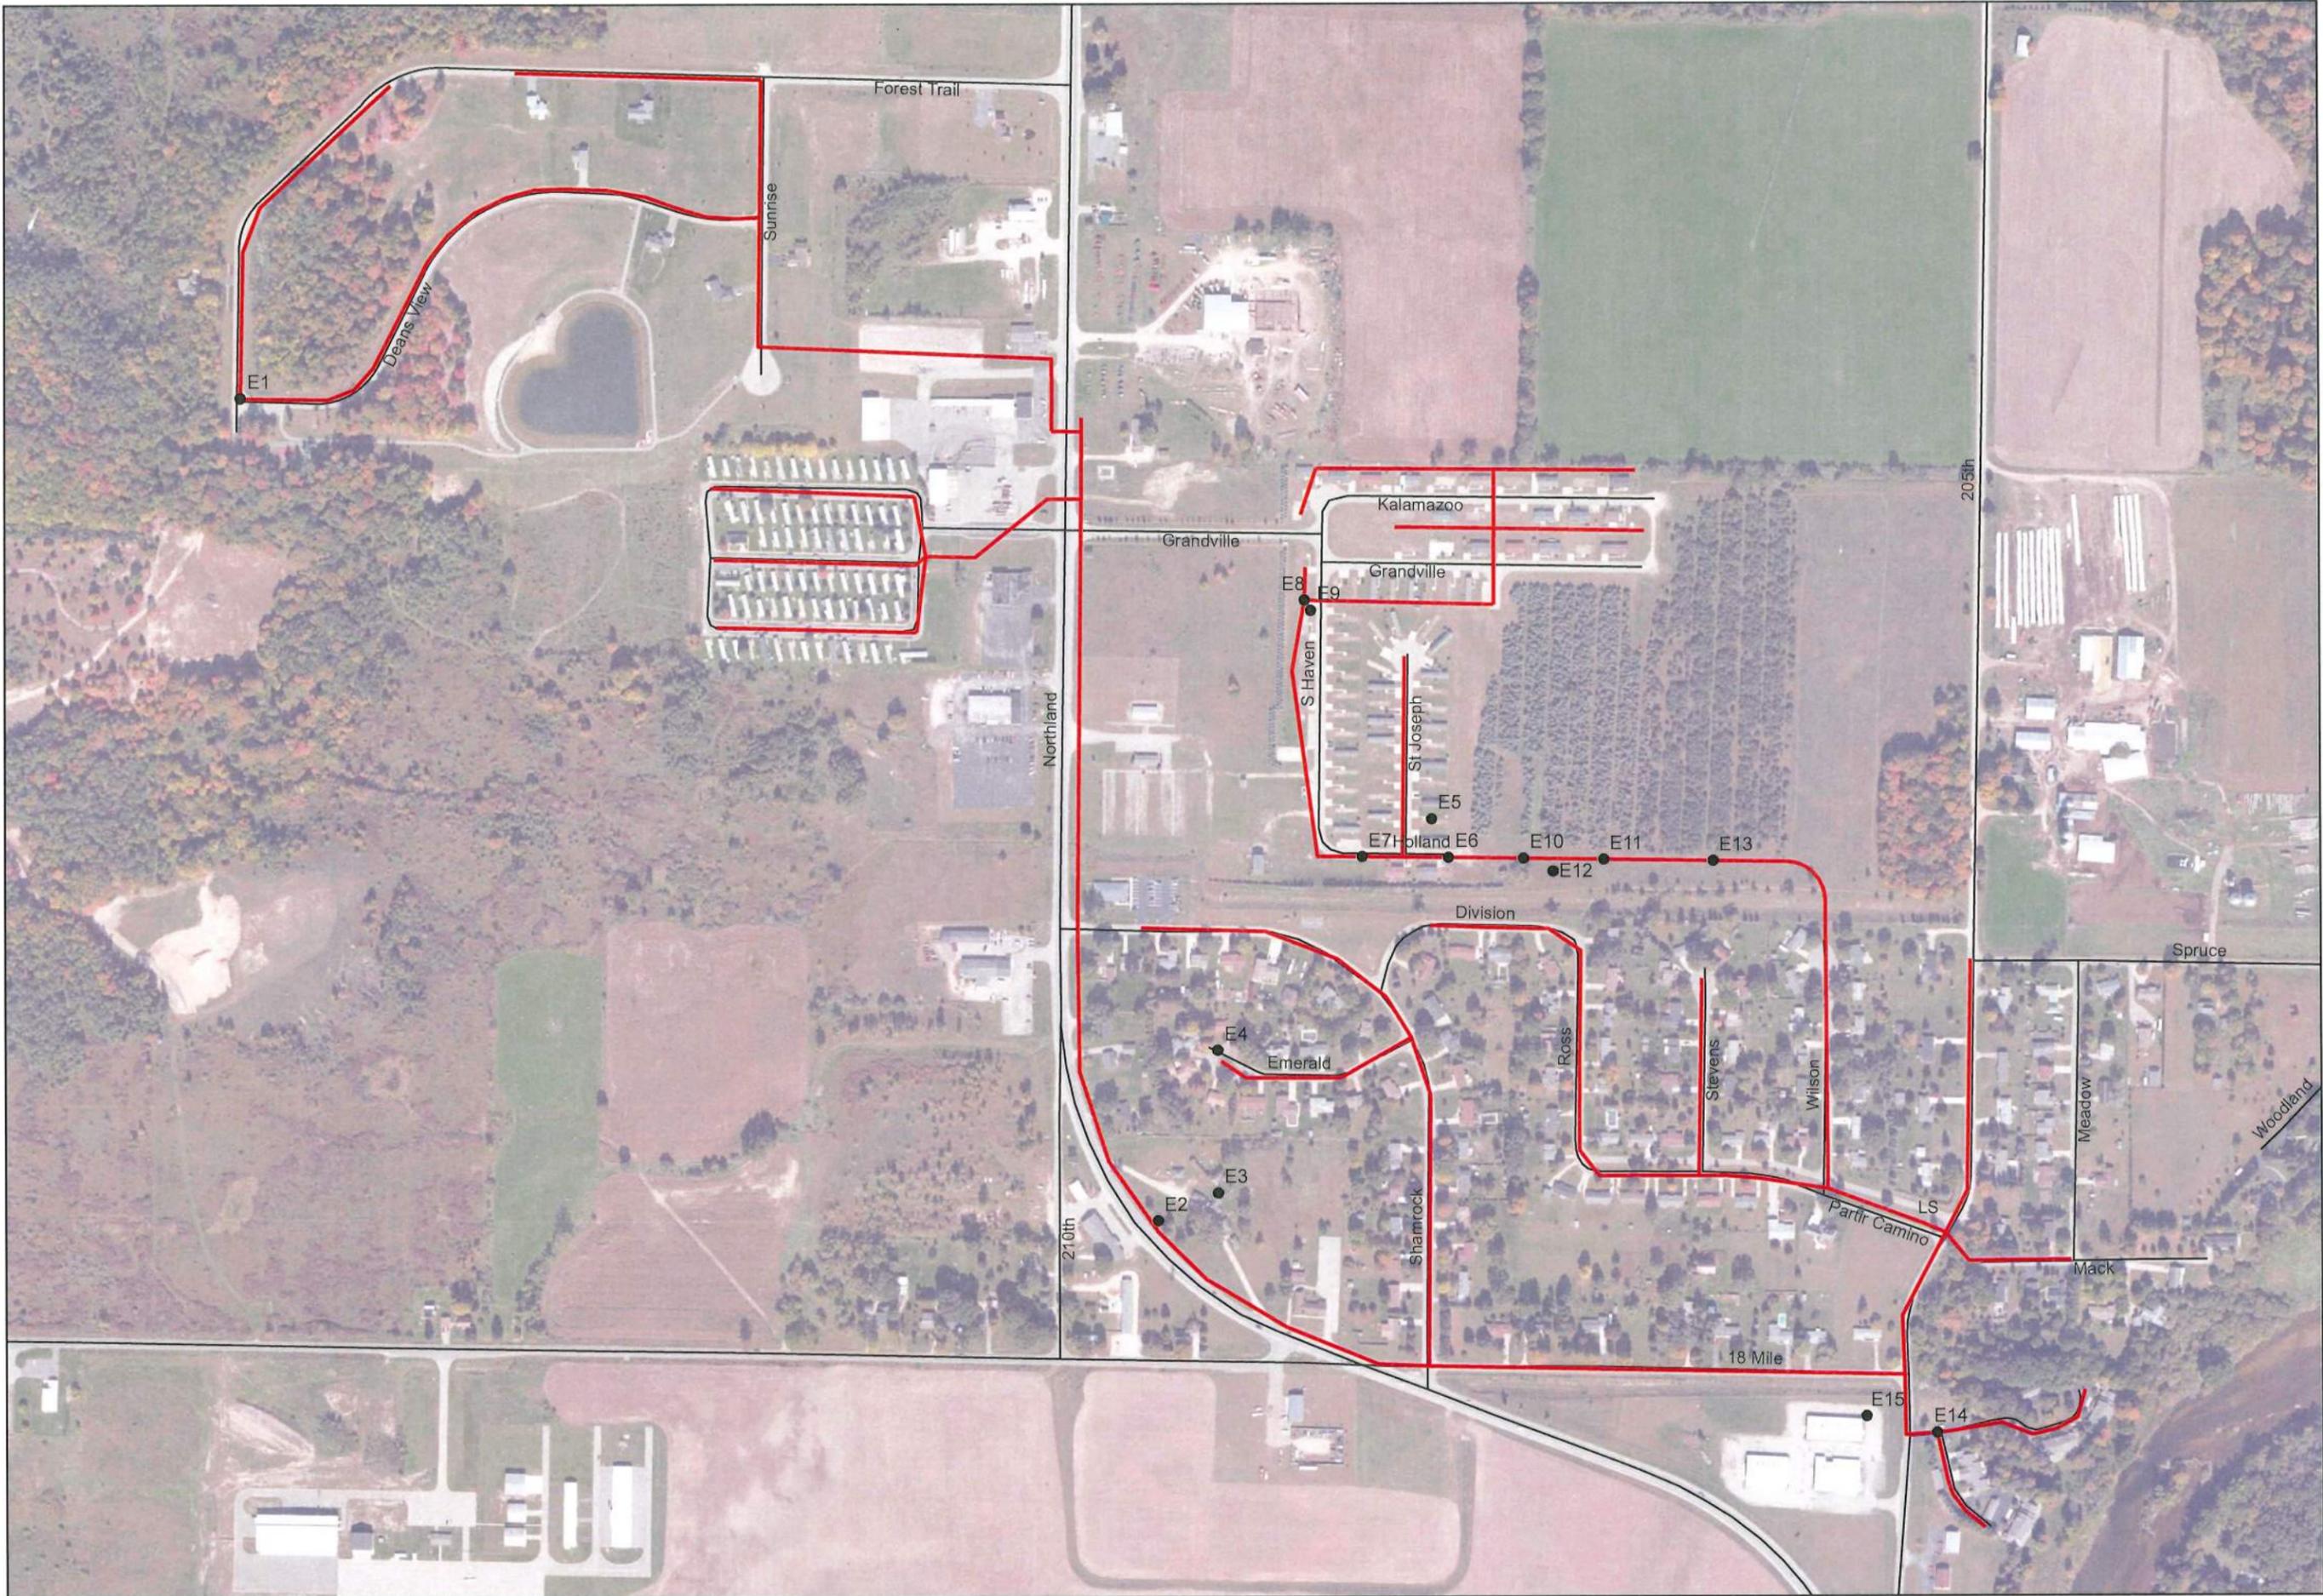
ATTACHMENT A
SMOKE TESTING MAP

Approximate Leak Locations

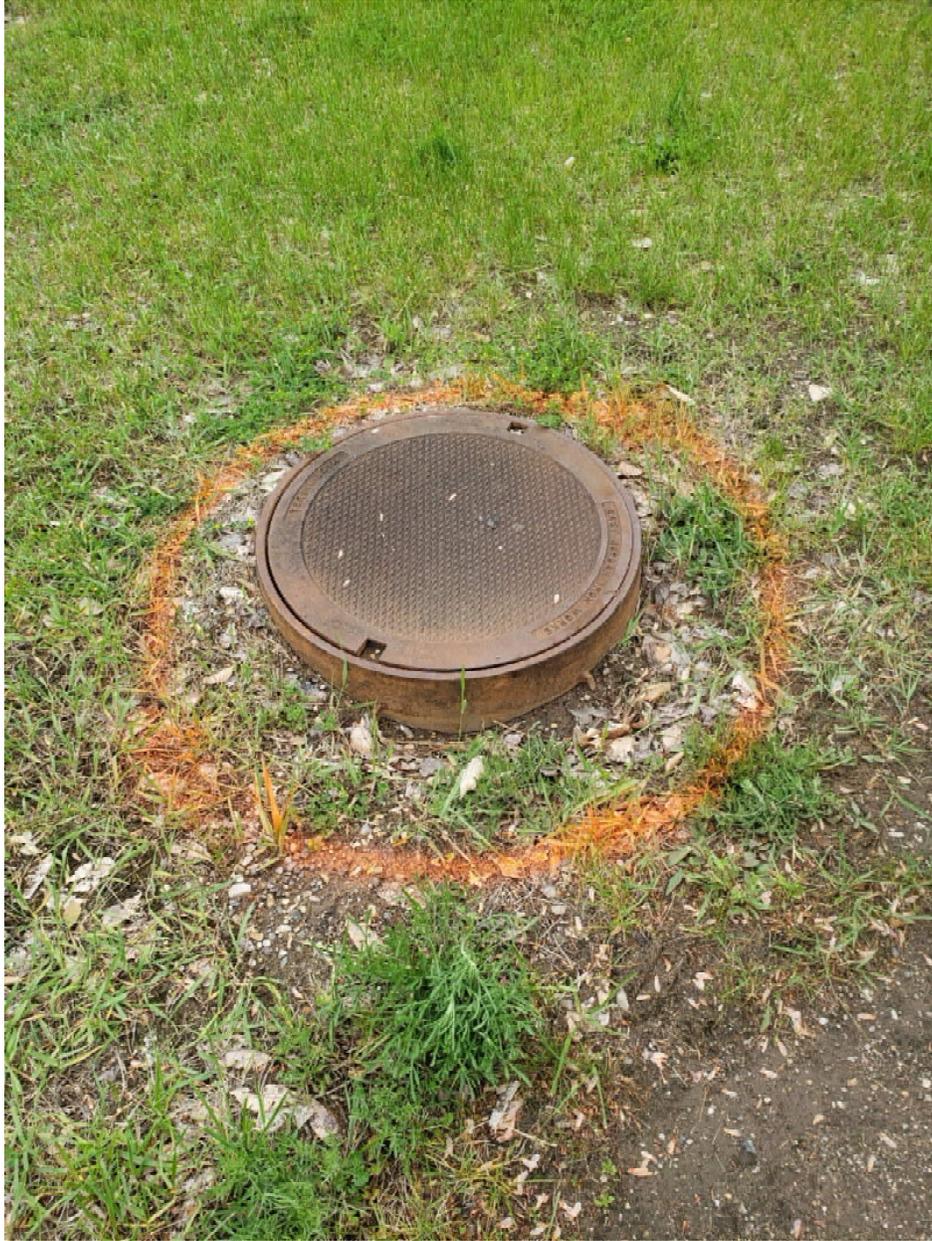
Event #1: Leaking Base on Sanitary Manhole 26 at the Corner of Dean's View and Forest Trail

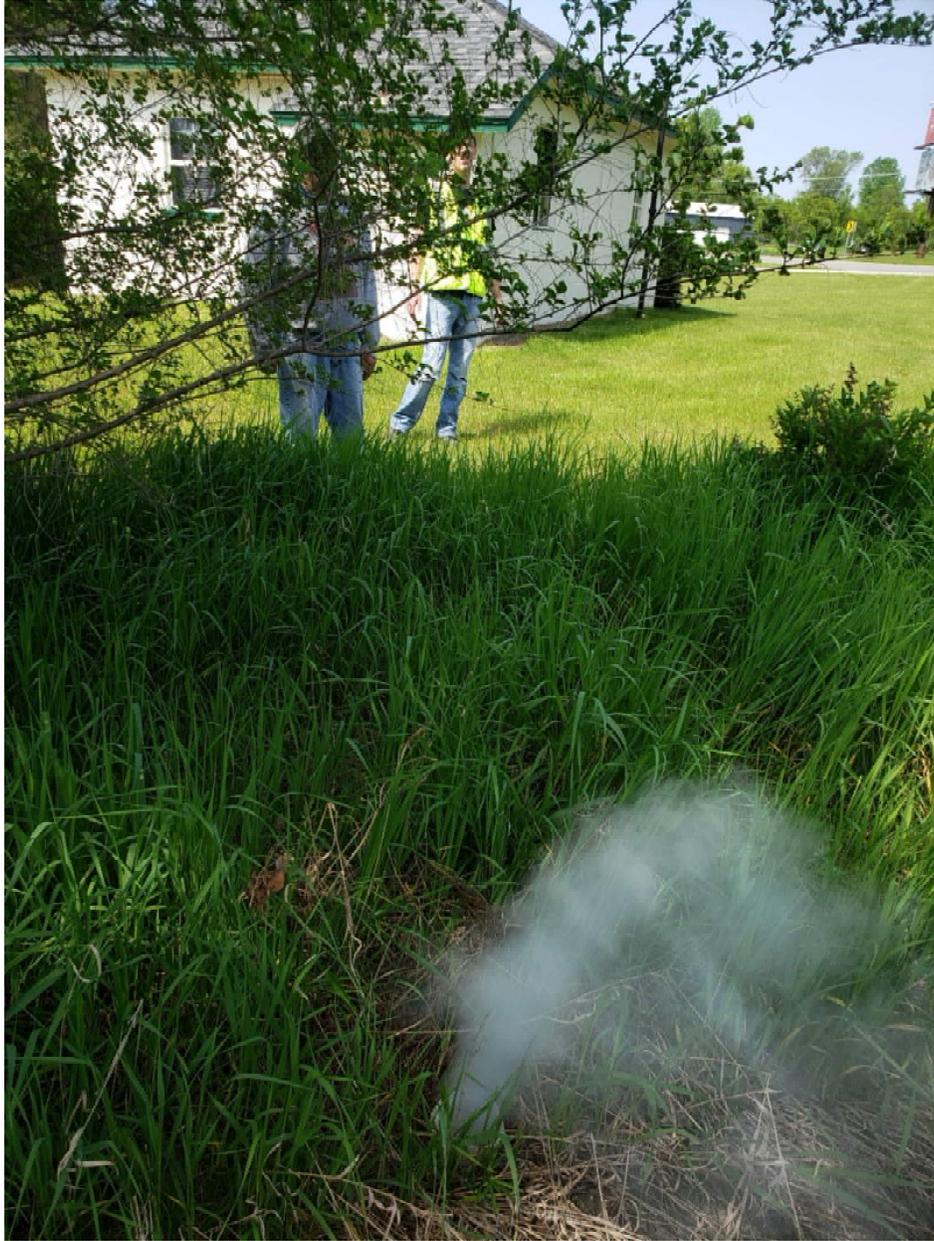
Event #2: Open Cleanout at Northland Drive Cabin #1

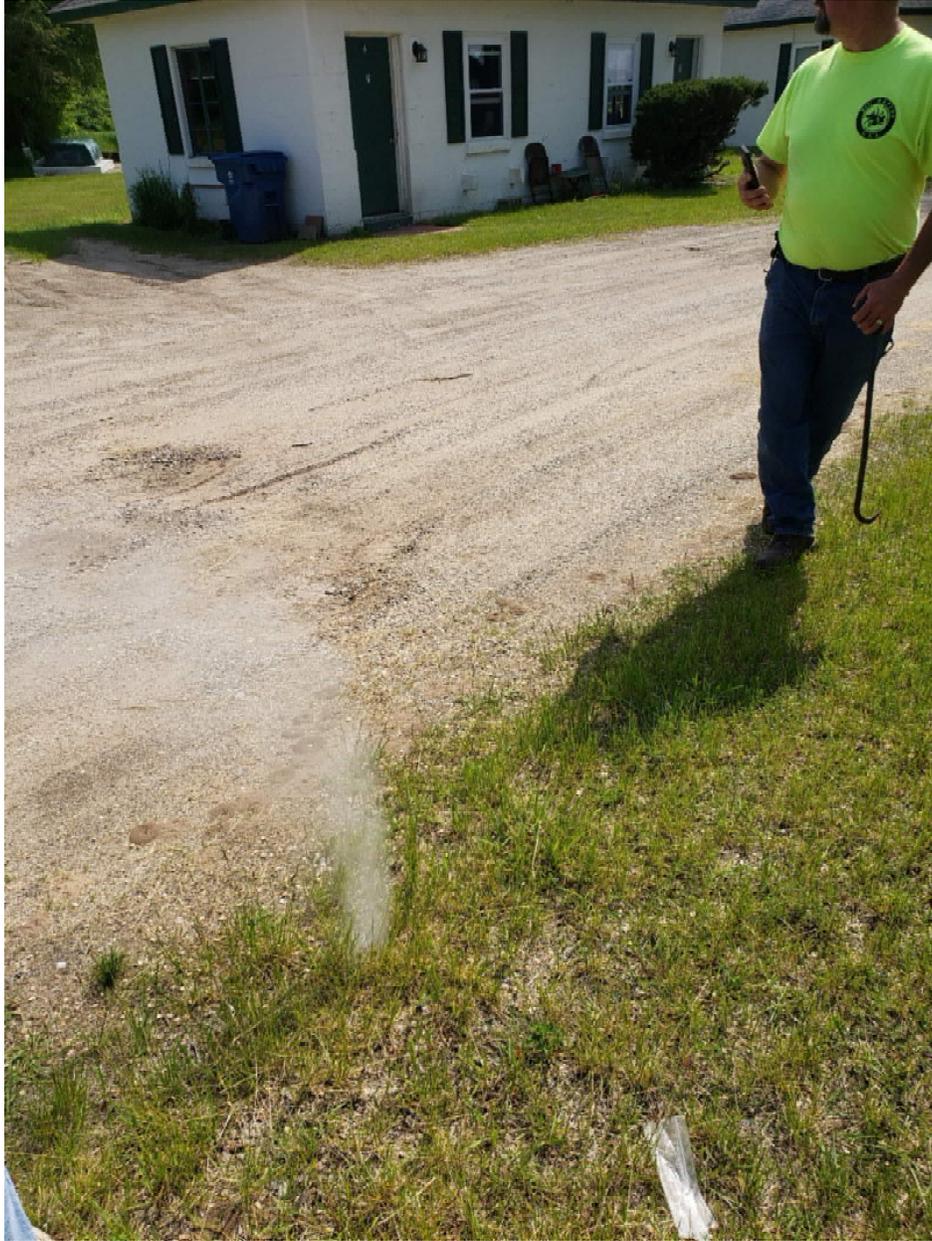
Event #3: Open Cleanout at Northland Drive Cabin #2

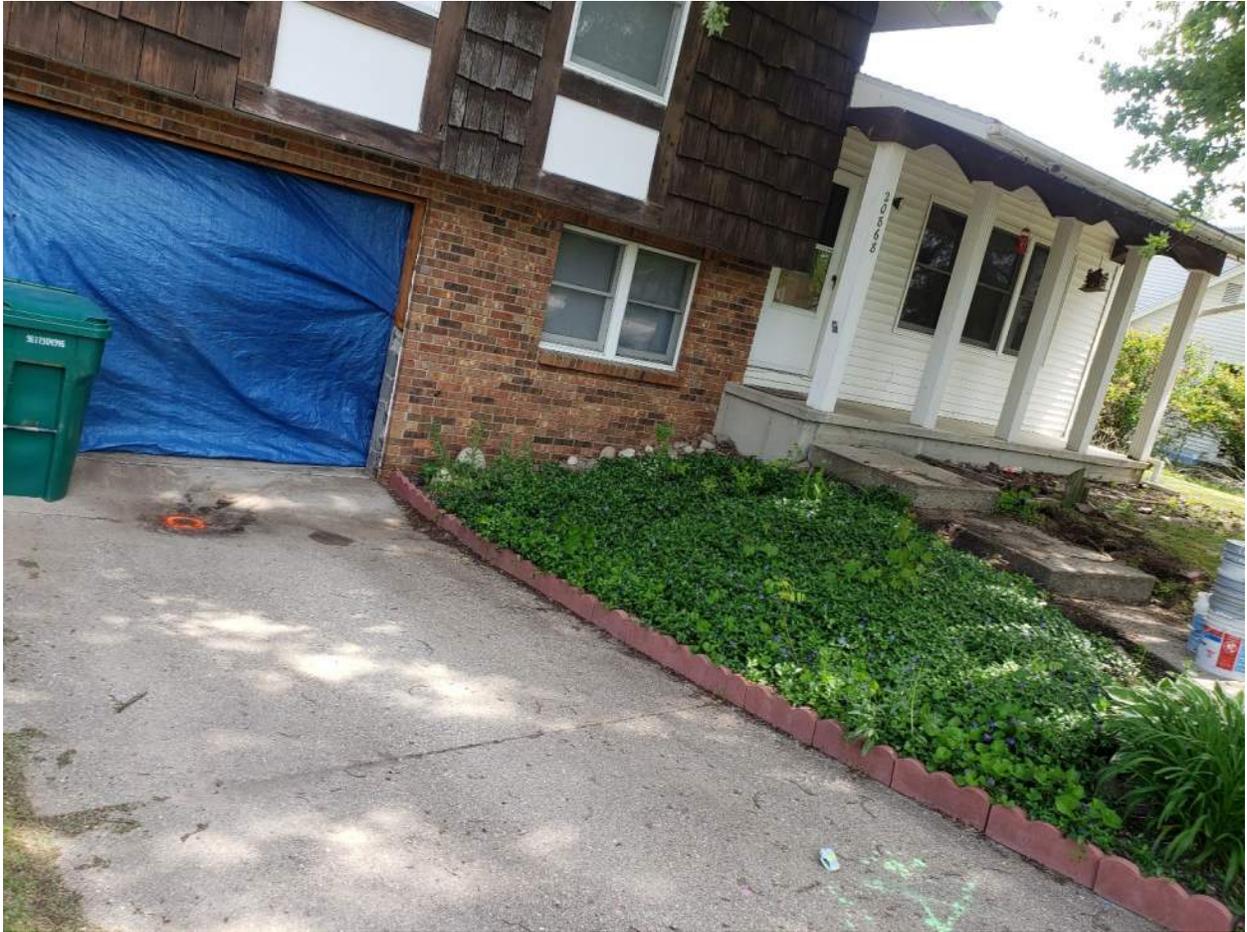
- 20868 Emerald Lane Driveway storm drain connected to sanitary sewer

Event #4: Storm Drain in Driveway connected to Sanitary Sewer at 20868 Emerald Lane

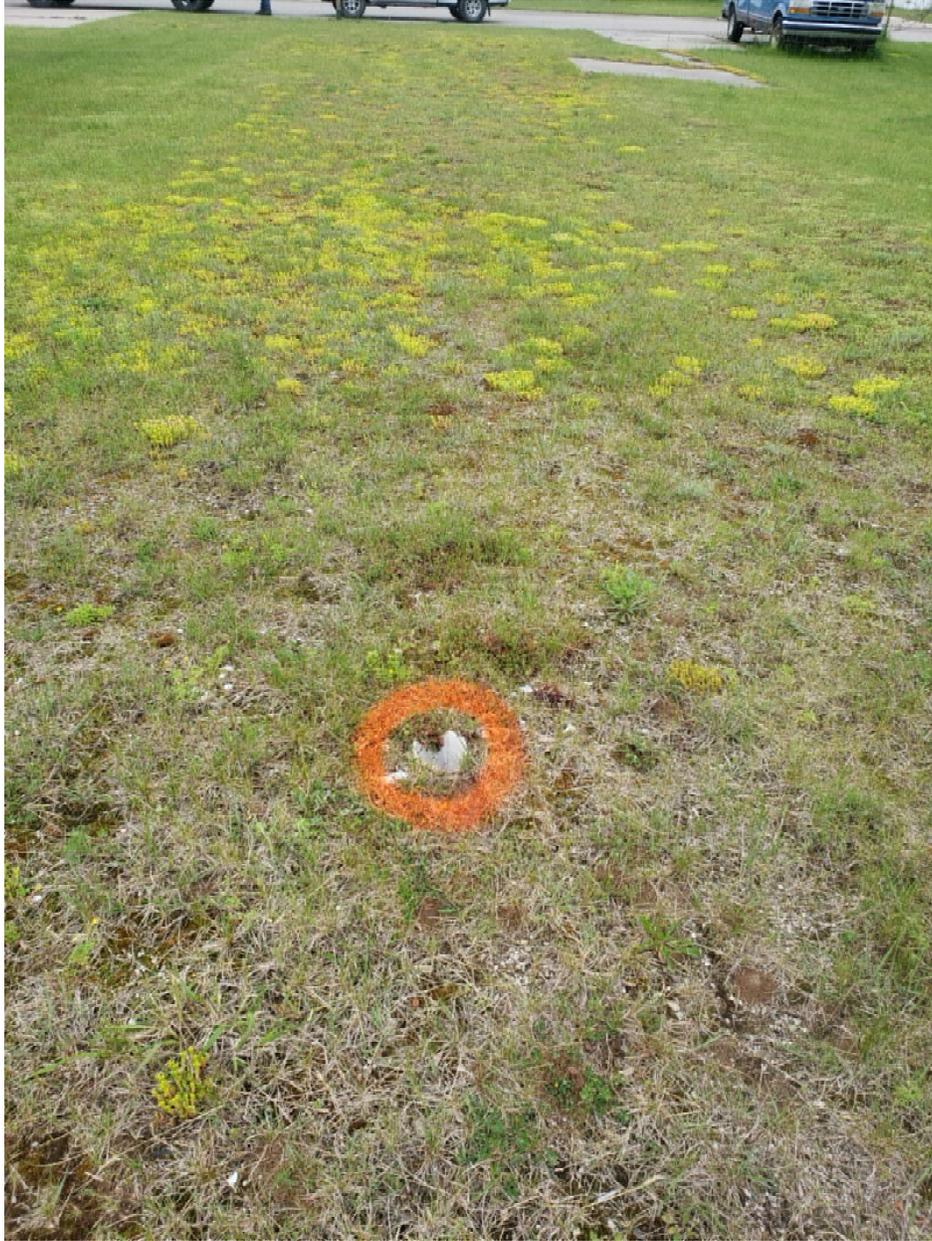
Event #5: Broken Cleanout on Lot #225 of the Country Manor Estates

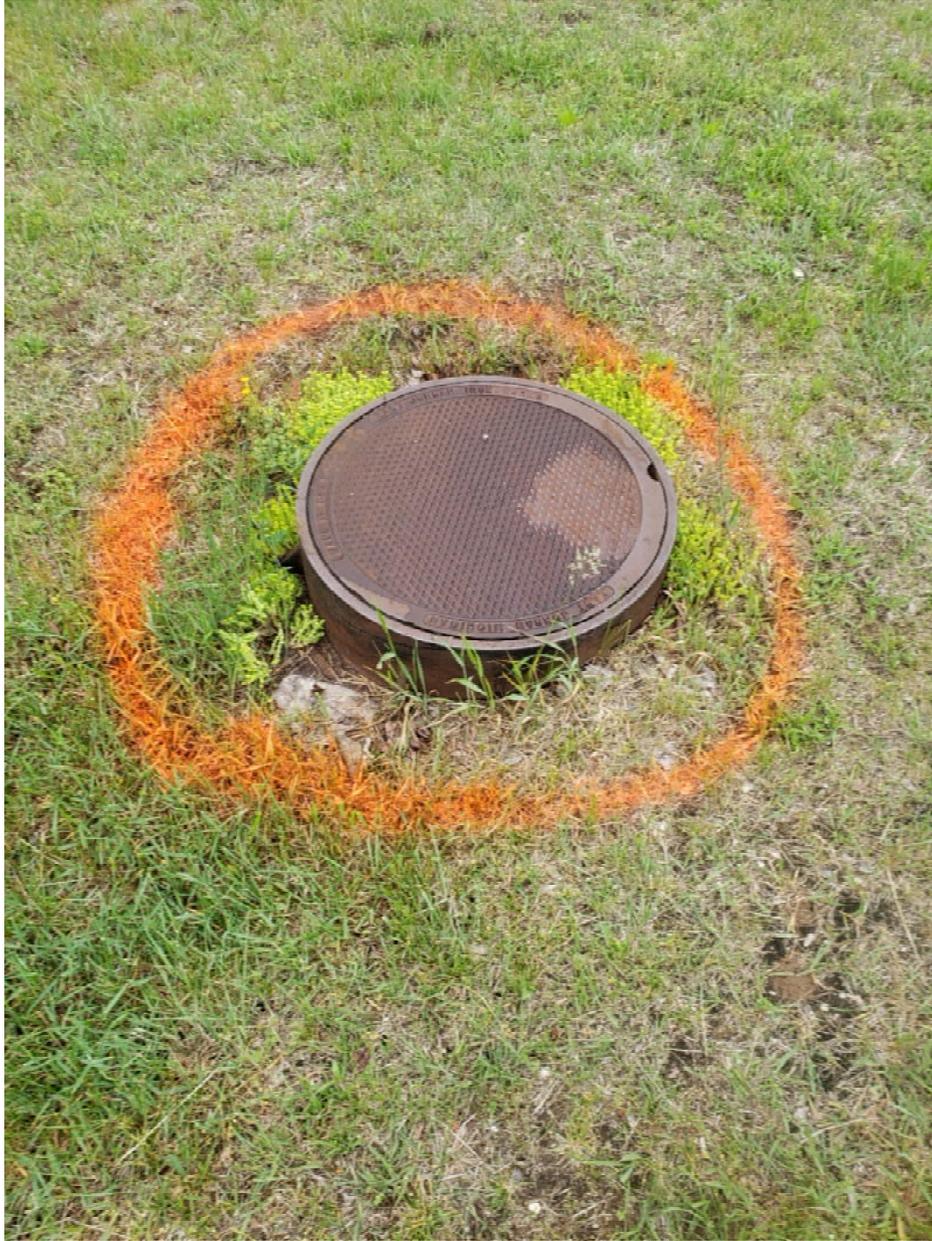
Event #6: Leaking Base on Manhole #6 on Holland Drive of the Country Manor Estates

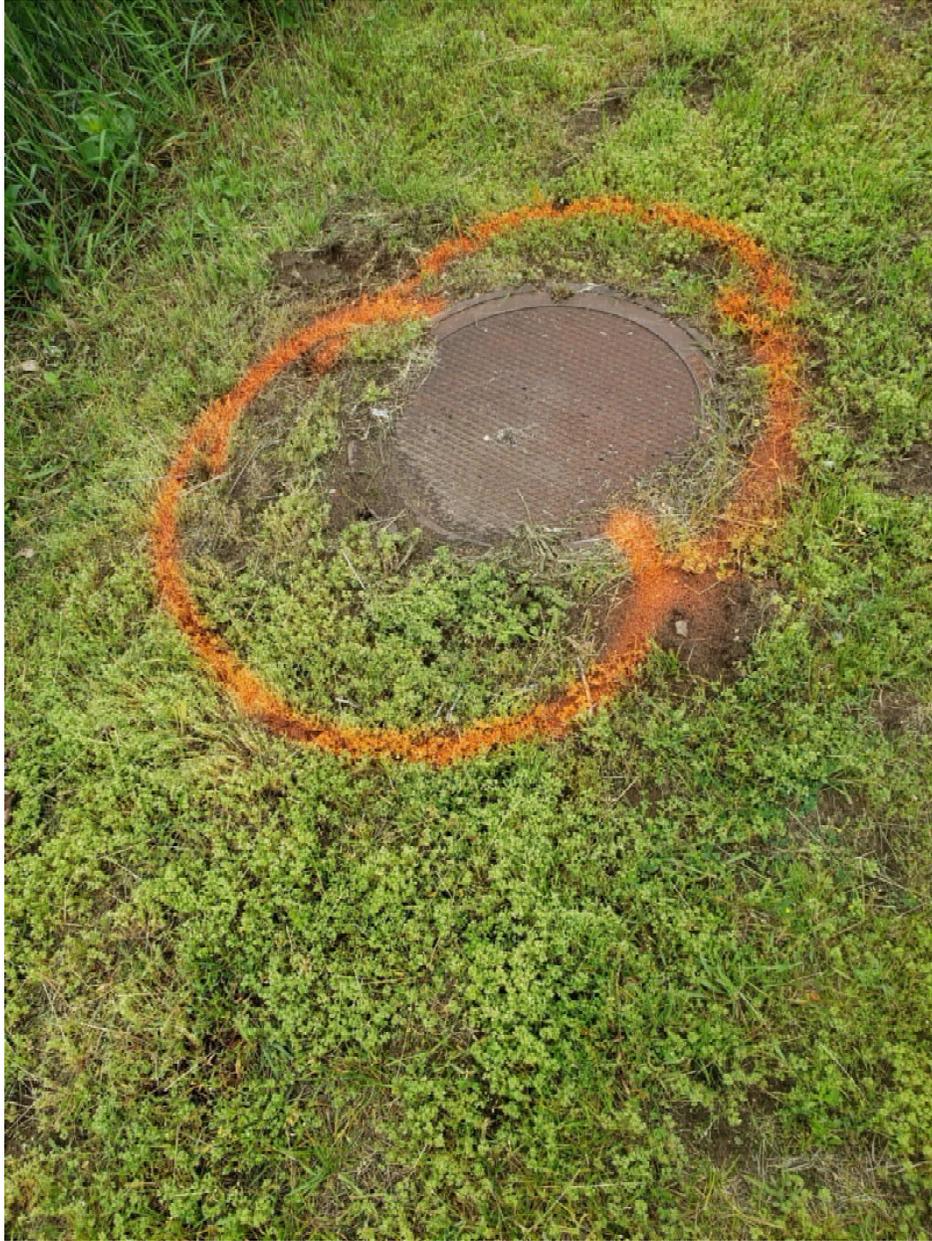
Event #7: Leaking Base on Manhole #7 on Holland Drive of the Country Manor Estates

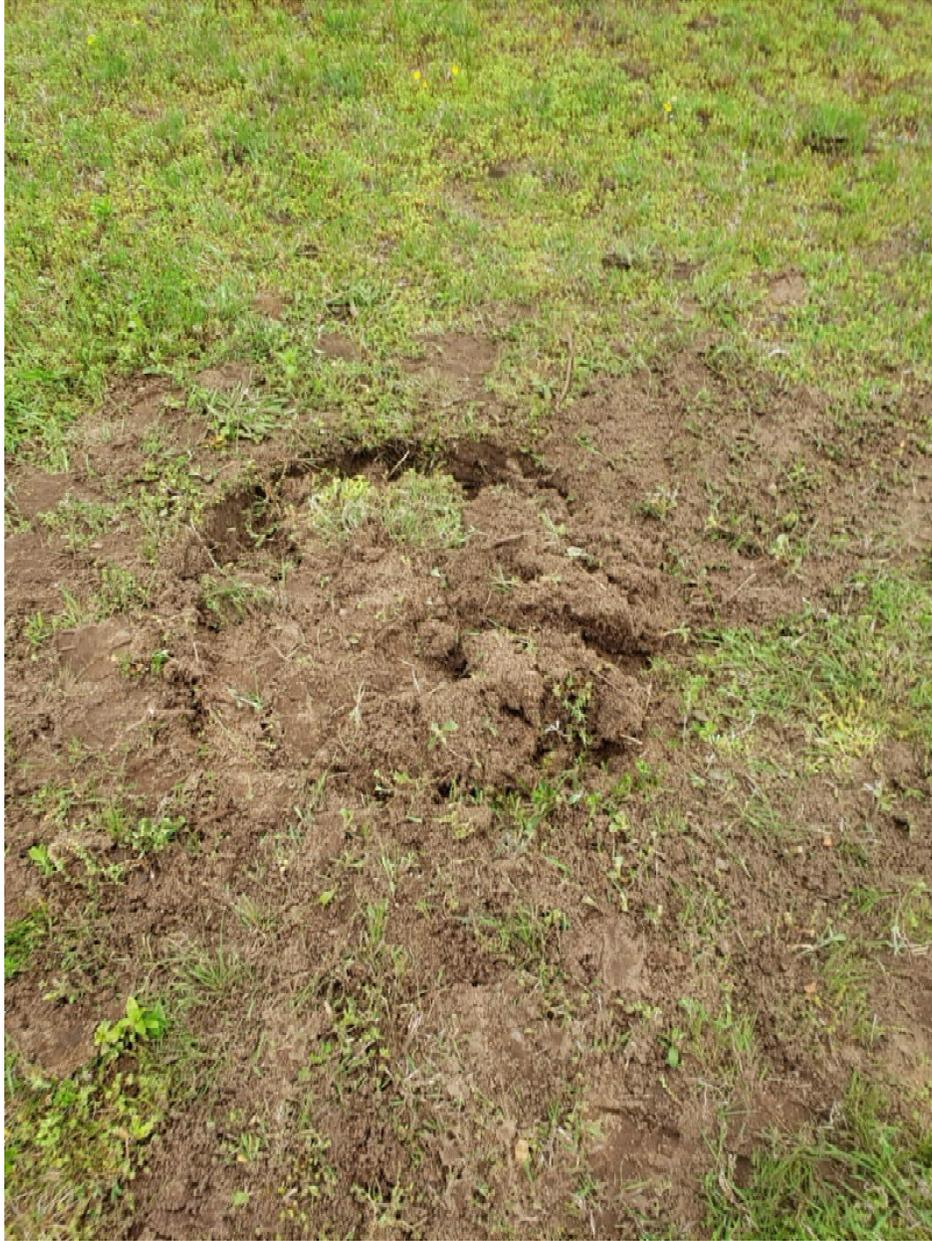
Event #8: Leaking Base on Manhole #9 South Haven Drive of the Country Manor Estates

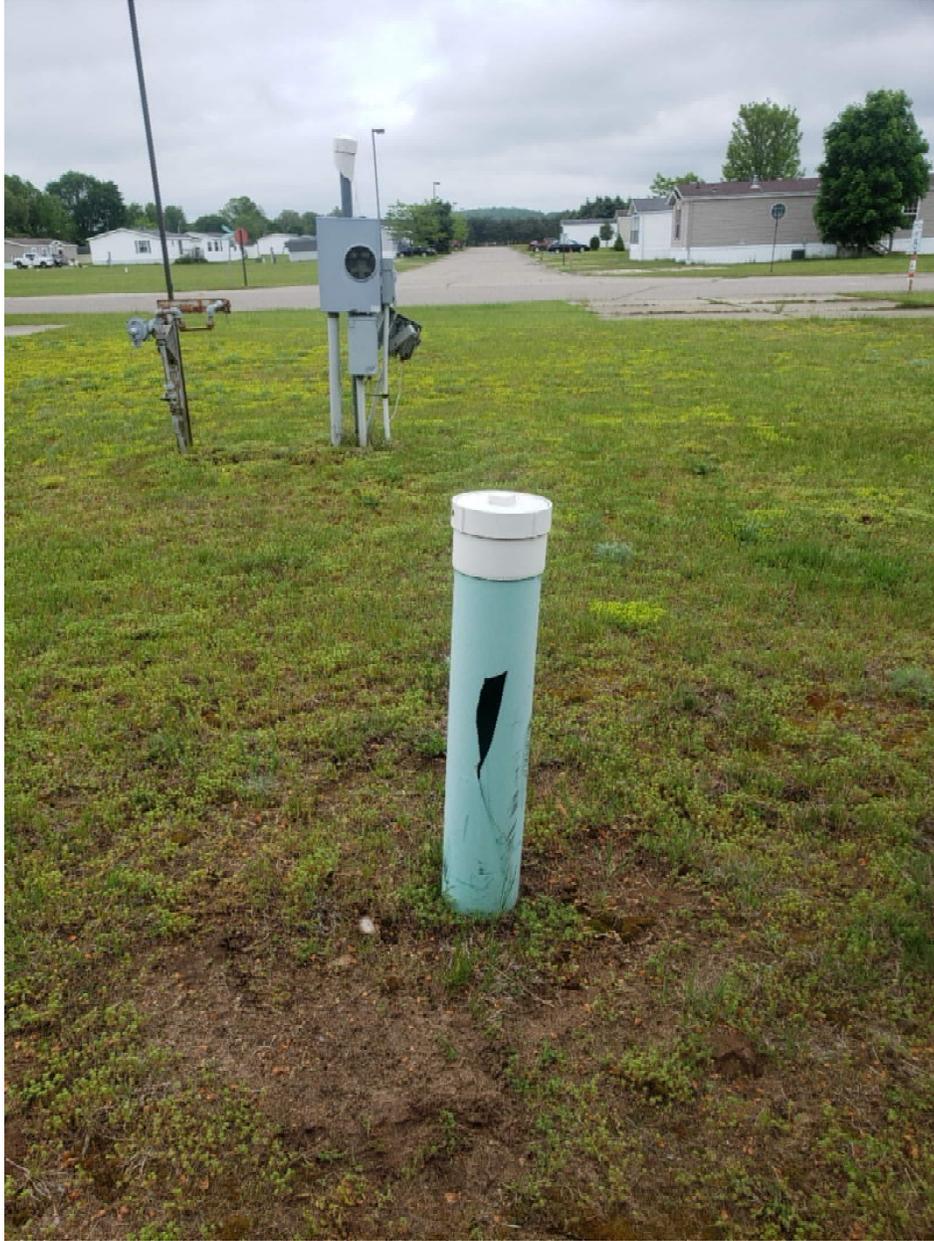
Event #9: Broken Clean Out #3 of Country Manor Estates

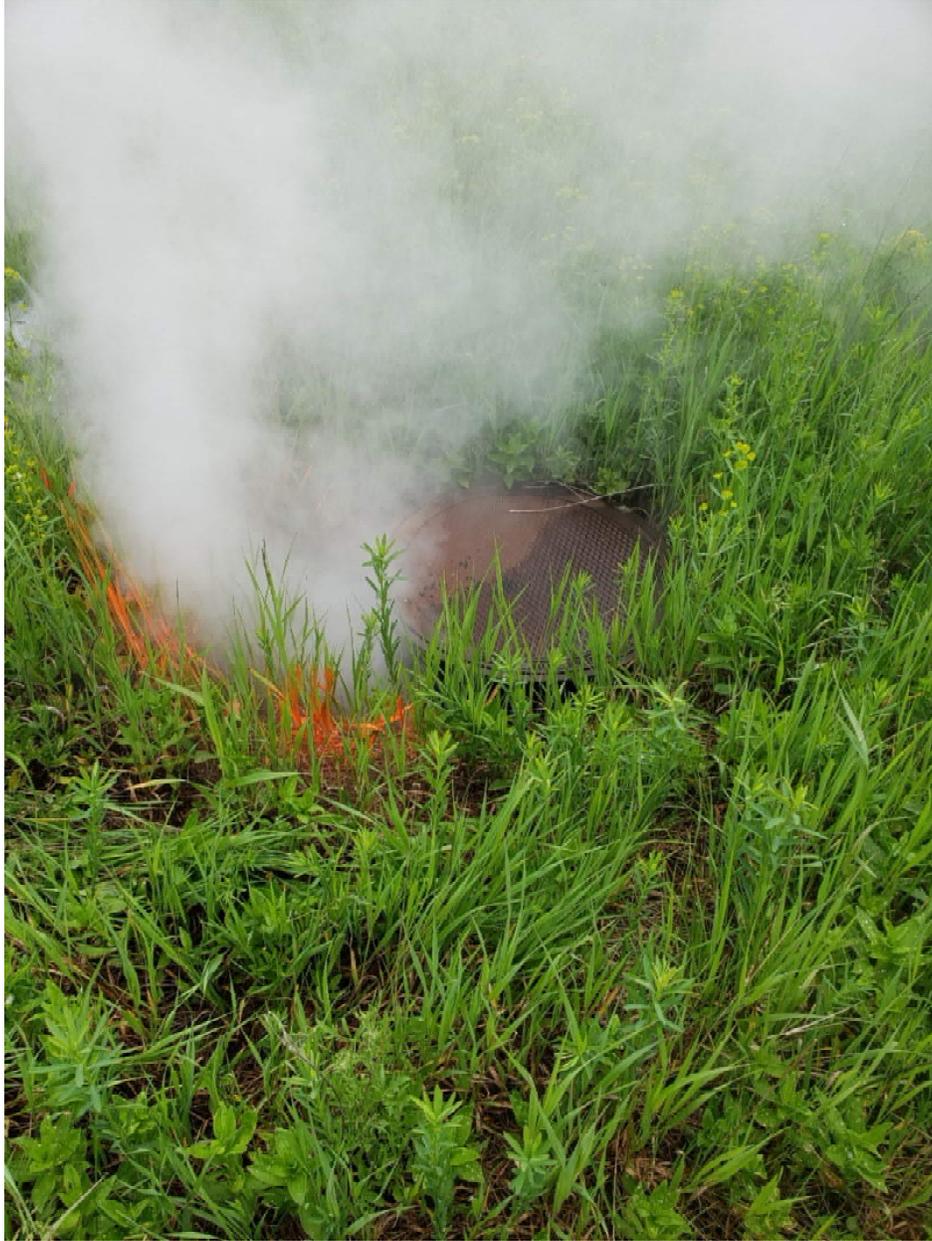
Event #10: Leaking Base on Manhole #5 on Holland Drive of the Country Manor Estates

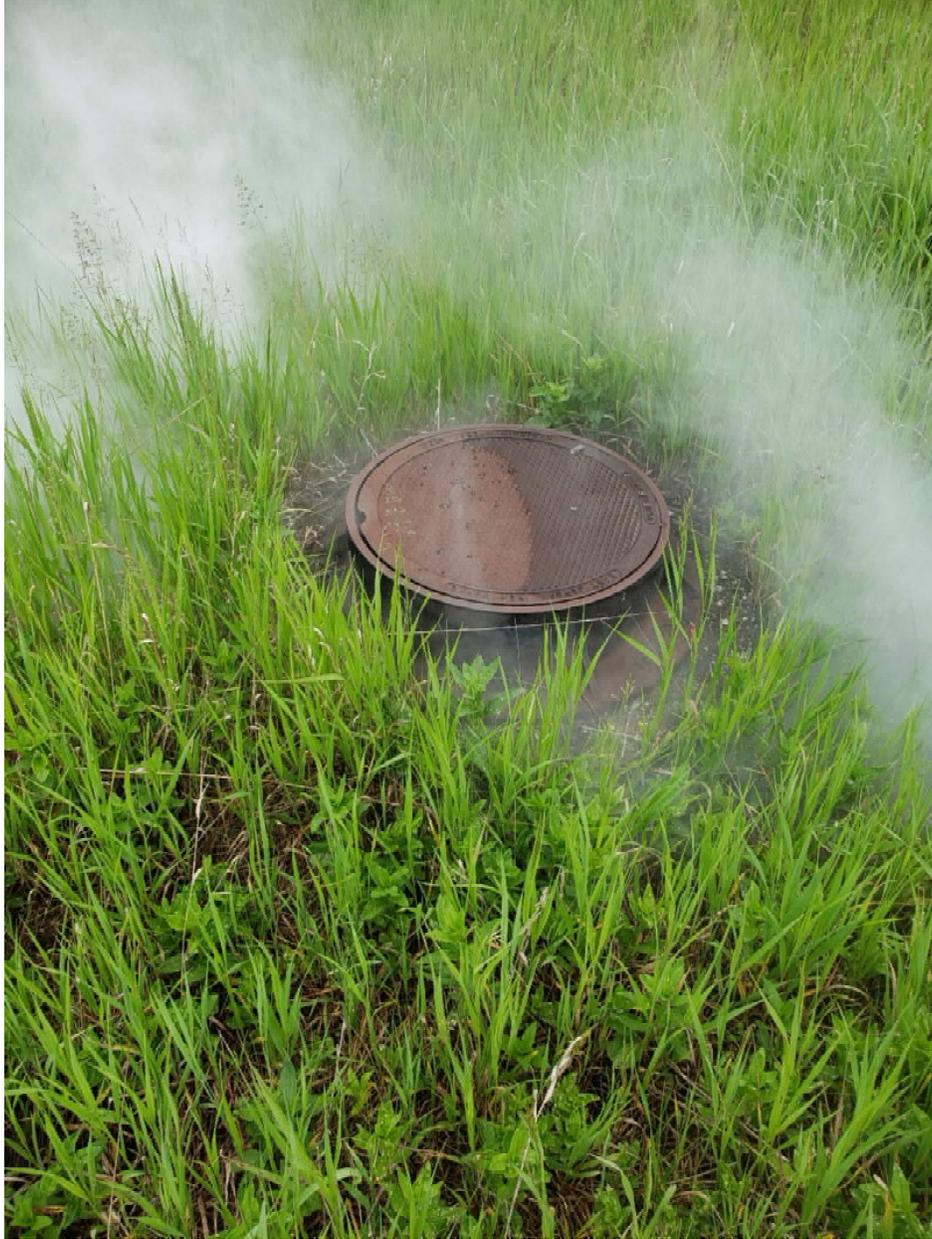
Event #11: Leaking Base on Manhole #4 on Holland Drive of the Country Manor Estates

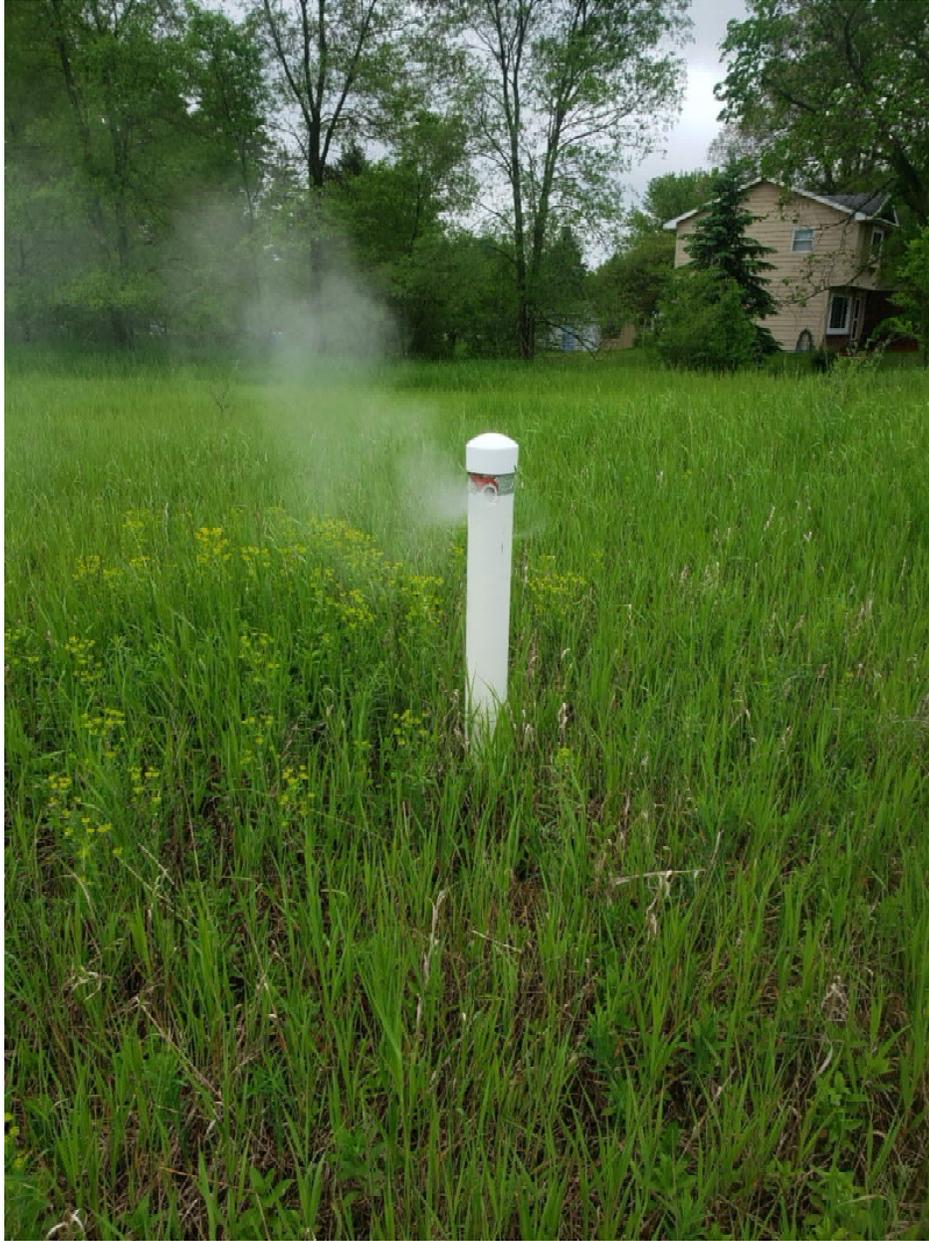
- Undeveloped lot 259/260 of the Country Manor Estates leaking lateral connection

Event #12: Leaking Lateral Connection for Undeveloped Lot 259/260 of the Country Manor Estates

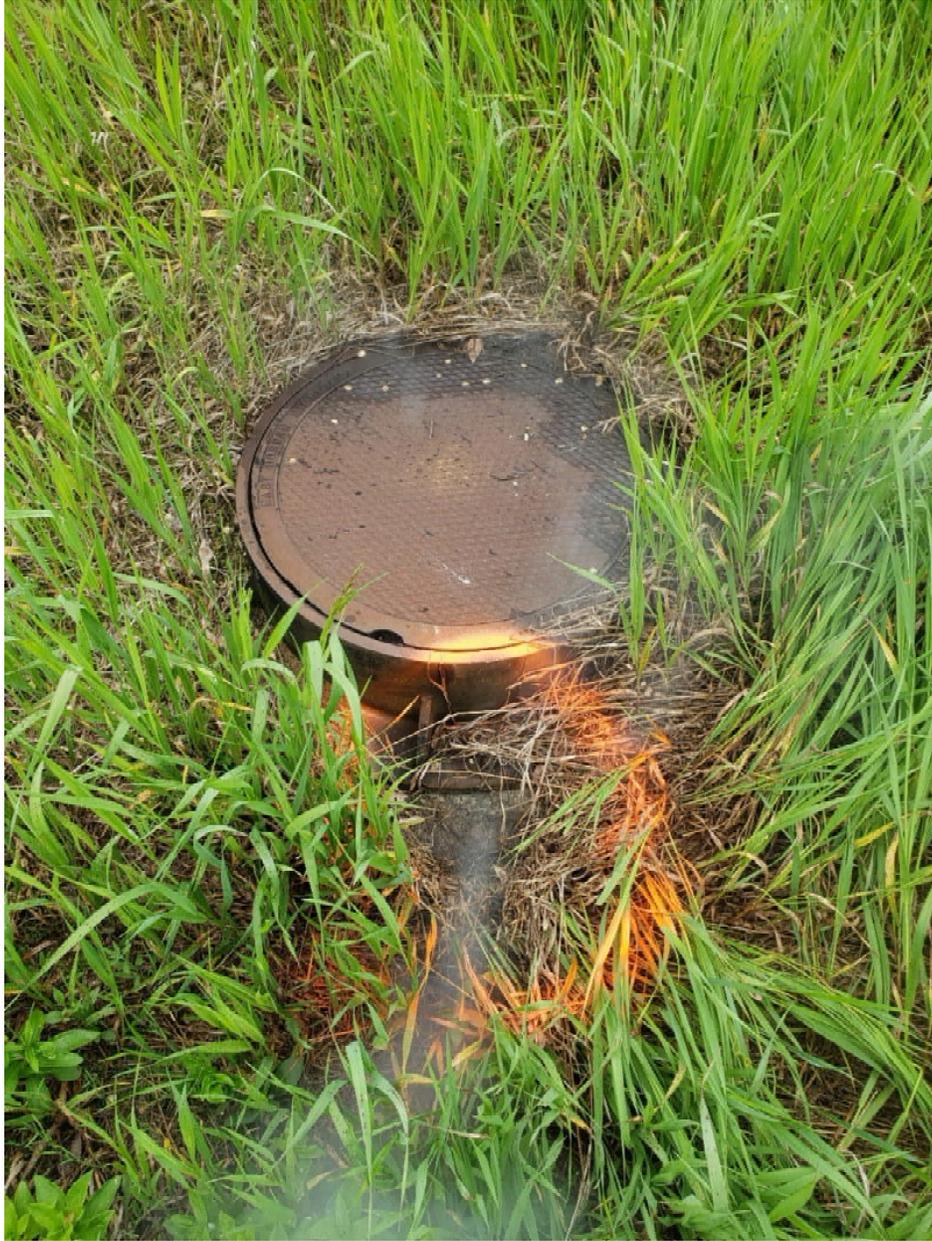
Event #13: Leaking Base on Manhole #2 on Holland Drive of the Country Manor Estates

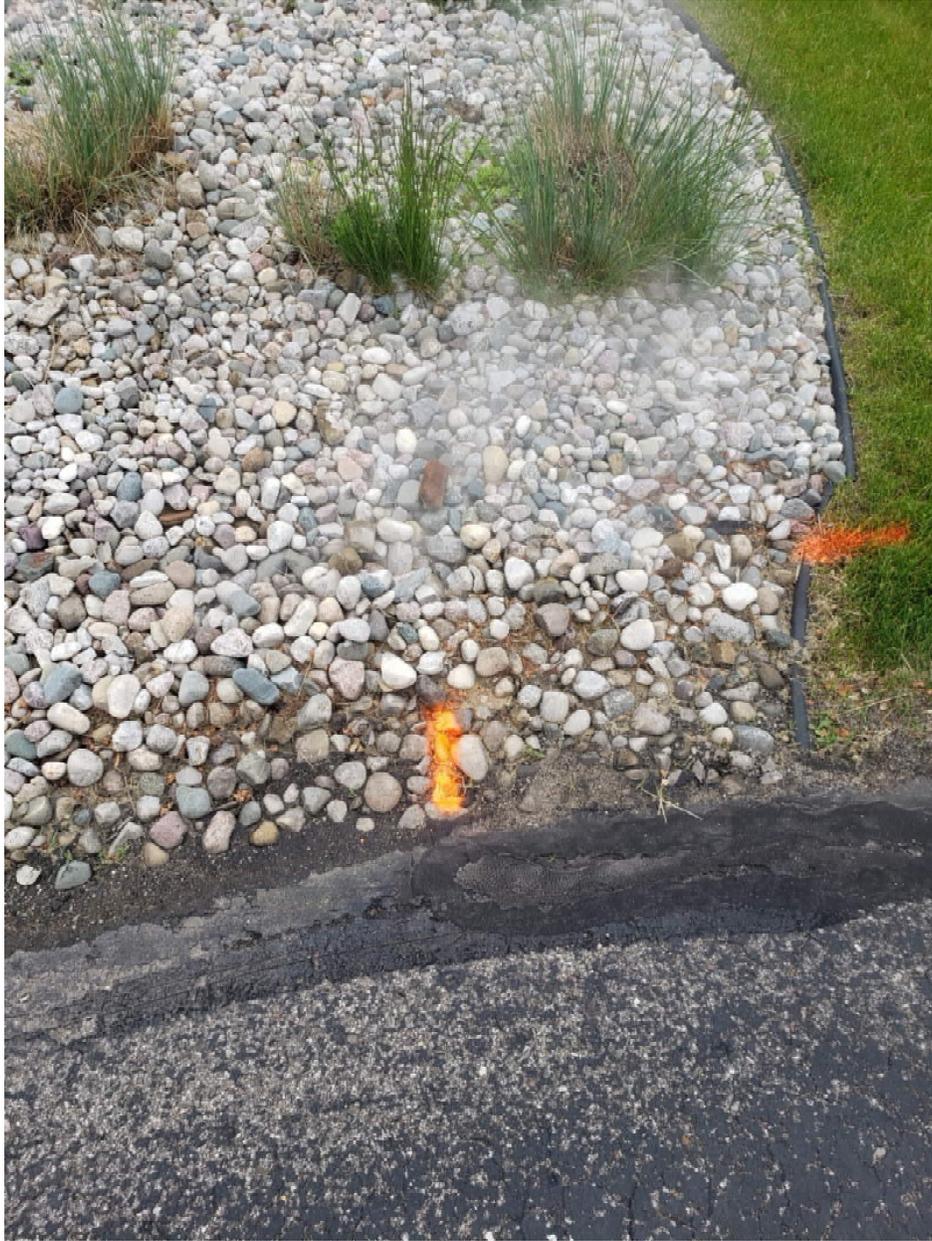
Event #14: Buried Clean Out at the River's Edge Comdominium Development Entrance

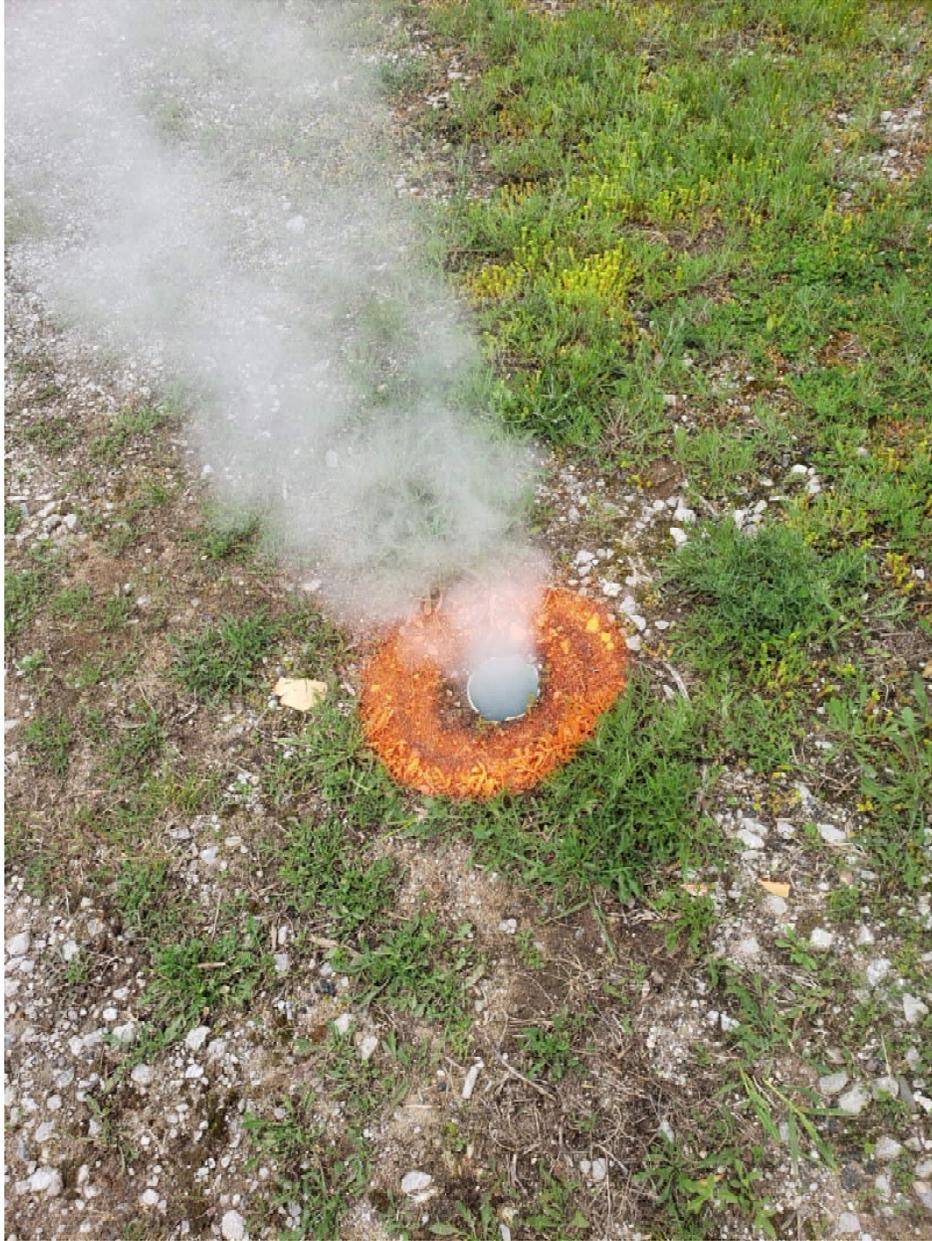
Event #15: Clean Out with no cap at the Northeast Corner of the Northeast Building of Old Carter's Lumber
